# Not in a Pickle: Steel Producer Secures Reliable Corrosion Protection Amidst Global Supply Crisis

Centro Orizaba,  
Veracruz, Mexico

Carbon Steel Sheet  
Metal Pickling

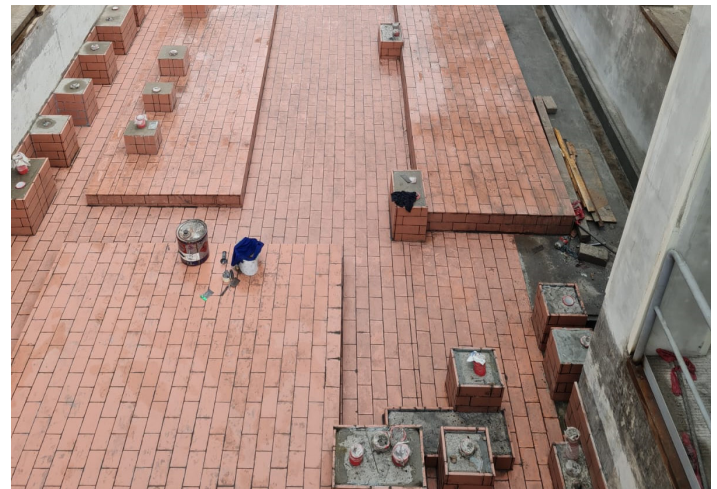
**1. Tile Installation** - ErgonArmor provided on-site technical support to the contractor during critical surface preparation, tile setting, grouting and detailing stages.

1. Chemical Containment Pit Flooring – Acid-resistant tile bonded with THINSET™ Adhesive and grouted with FURALAC™ Green Panel Mortar
2. Chemical Containment Pit Walls, Pickling Line Platform Support Columns, Floor under Pickling Line Platform – Novocoat™ SC3300 Novolac Epoxy Lining over Novocoat™ SC1100 Primer/Sealer with fiberglass reinforcement

Initially, TYASA considered using a vinyl ester laminate lining under the chemical storage tanks but ultimately chose acid-resistant tile for two reasons: scheduling and reliability. TYASA wanted to set the tanks 18 days after placing concrete, but in humid Veracruz, the concrete would have had to cure at least 28 days for the vinyl ester laminate to adhere. In contrast, tile setting could start after 7 days' cure, saving 3 weeks or more. The thick, rugged tile bonded with THINSET™ Adhesive and grouted with FURALAC™ Green Panel Mortar also offered superior longevity, a better choice for the inaccessible floors underneath the pickling solution tanks and piping.

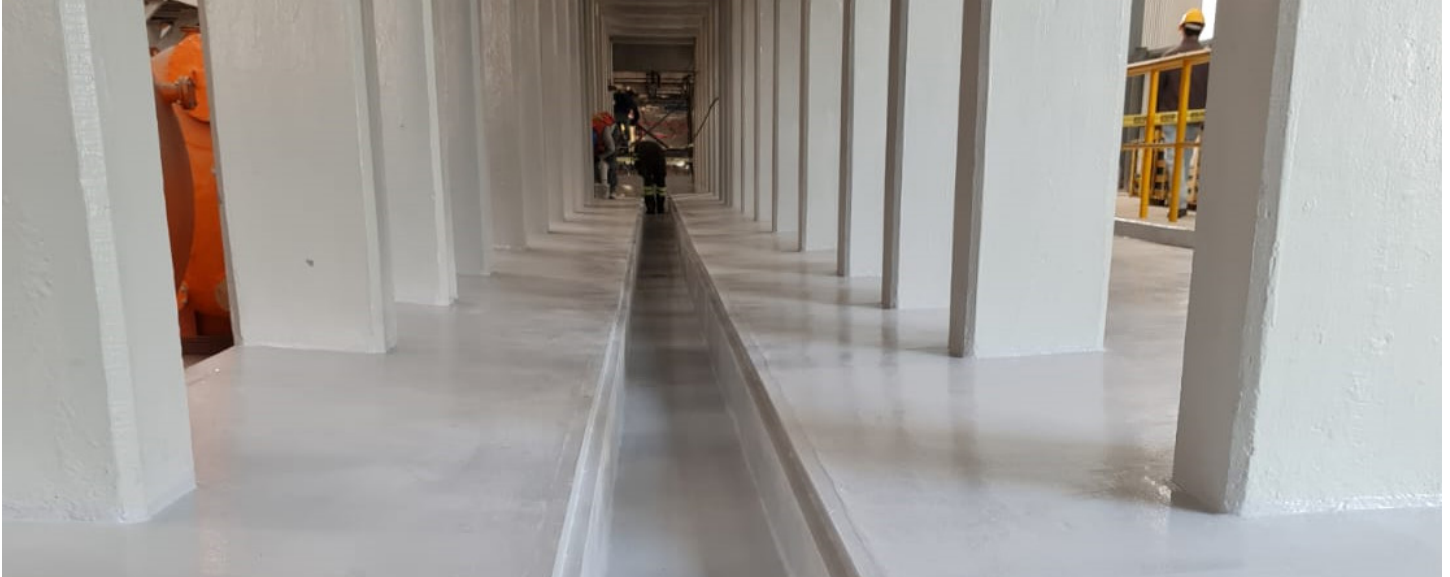
**2. Floor, Wall, and Column Coating Installation** – A lighter-duty, fiberglass reinforced coating on the columns and floor underneath the elevated pickling line platform.

Because the walls of the chemical storage pit and the floor and columns under the pickling line platform would be more easily accessible, a more cost-effective novolac epoxy laminate system provided better value. To enhance the lining's resilience on expanding and contracting concrete, the primer was reinforced with chopped strand fiberglass mat that also increased durability.

On top, Novocoat™ SC3300 Novolac Epoxy Lining was applied to block the corrosive pickling solution.
