# Installation of Precast Sulfur Pit Constructed with ErgonArmor's TUFCEM™ Silicate Concrete

**Challenge:** Sulfur pit replacement using a more chemical-resistant concrete than portland cement

**Solution:** Creation of replacement sulfur pit using TUFCEM Silicate Concrete - Foundation Grade with TUFCEM II Membrane outer lining

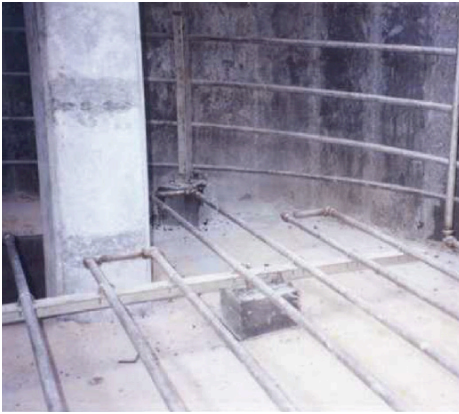
1. Steam pipes that are used to dissolve the sulfur when the sulfur pit is in full operation.

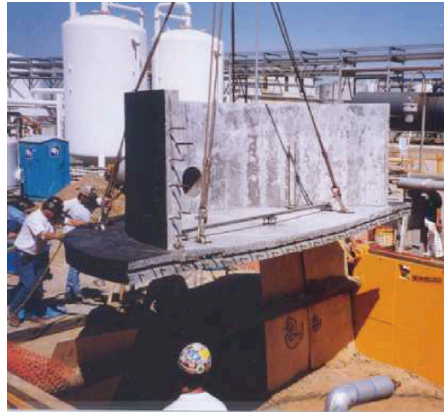
2. Installation of the first half of the sulfur pit being lowered into the ground.

ErgonArmor opted for a sulfur pit entirely constructed from TSC-FG. Reinforcement was similar to that for a PCC structure, in addition an acid proof urethane asphaltic membrane TUFCEM II Membrane was installed on the back side. To limit downtime the pit was cast in two sections and joined together. ErgonArmor's TSC-FG is a more economical, higher strength and rapid setting acid-resistant silicate concrete than other silicate concretes. This product is specially formulated for the casting method of construction and is treated similarly to Portland cement concrete with respect to forming, mixing, reinforcing, placement, and curing. The plant engineer said that he was very pleased with the two week installation period, which resulted in minimum shutdown time and quick return to the plant productivity.

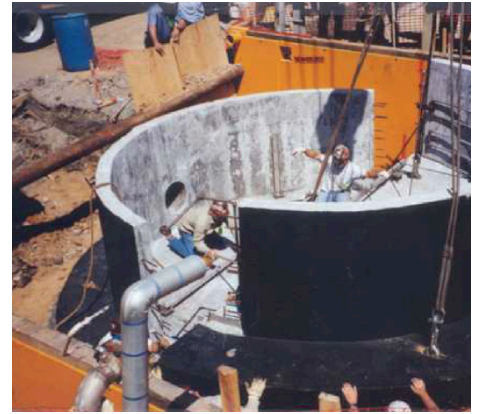
3. The second half of the sulfur pit being assembled with the first half.

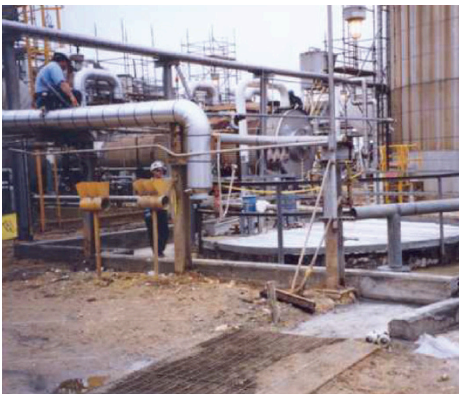
4. Completed sulfur pit from a ground view

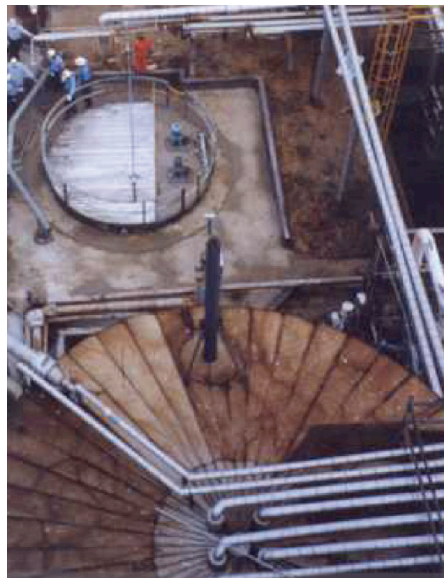
5. Completed sulfur pit from an aerial view
